# K. SMART ASSOCIATES LIMITED

February 4, 2022

File No. 22-065

**RE: STRUCTURE 34/B-T9 (BRIDGE STREET BRIDGE)  
RECOMMENDATIONS FOLLOWING EMERGENCY CLOSURE  
TRAFFIC ACCIDENT AND FIRE ON BRIDGE**

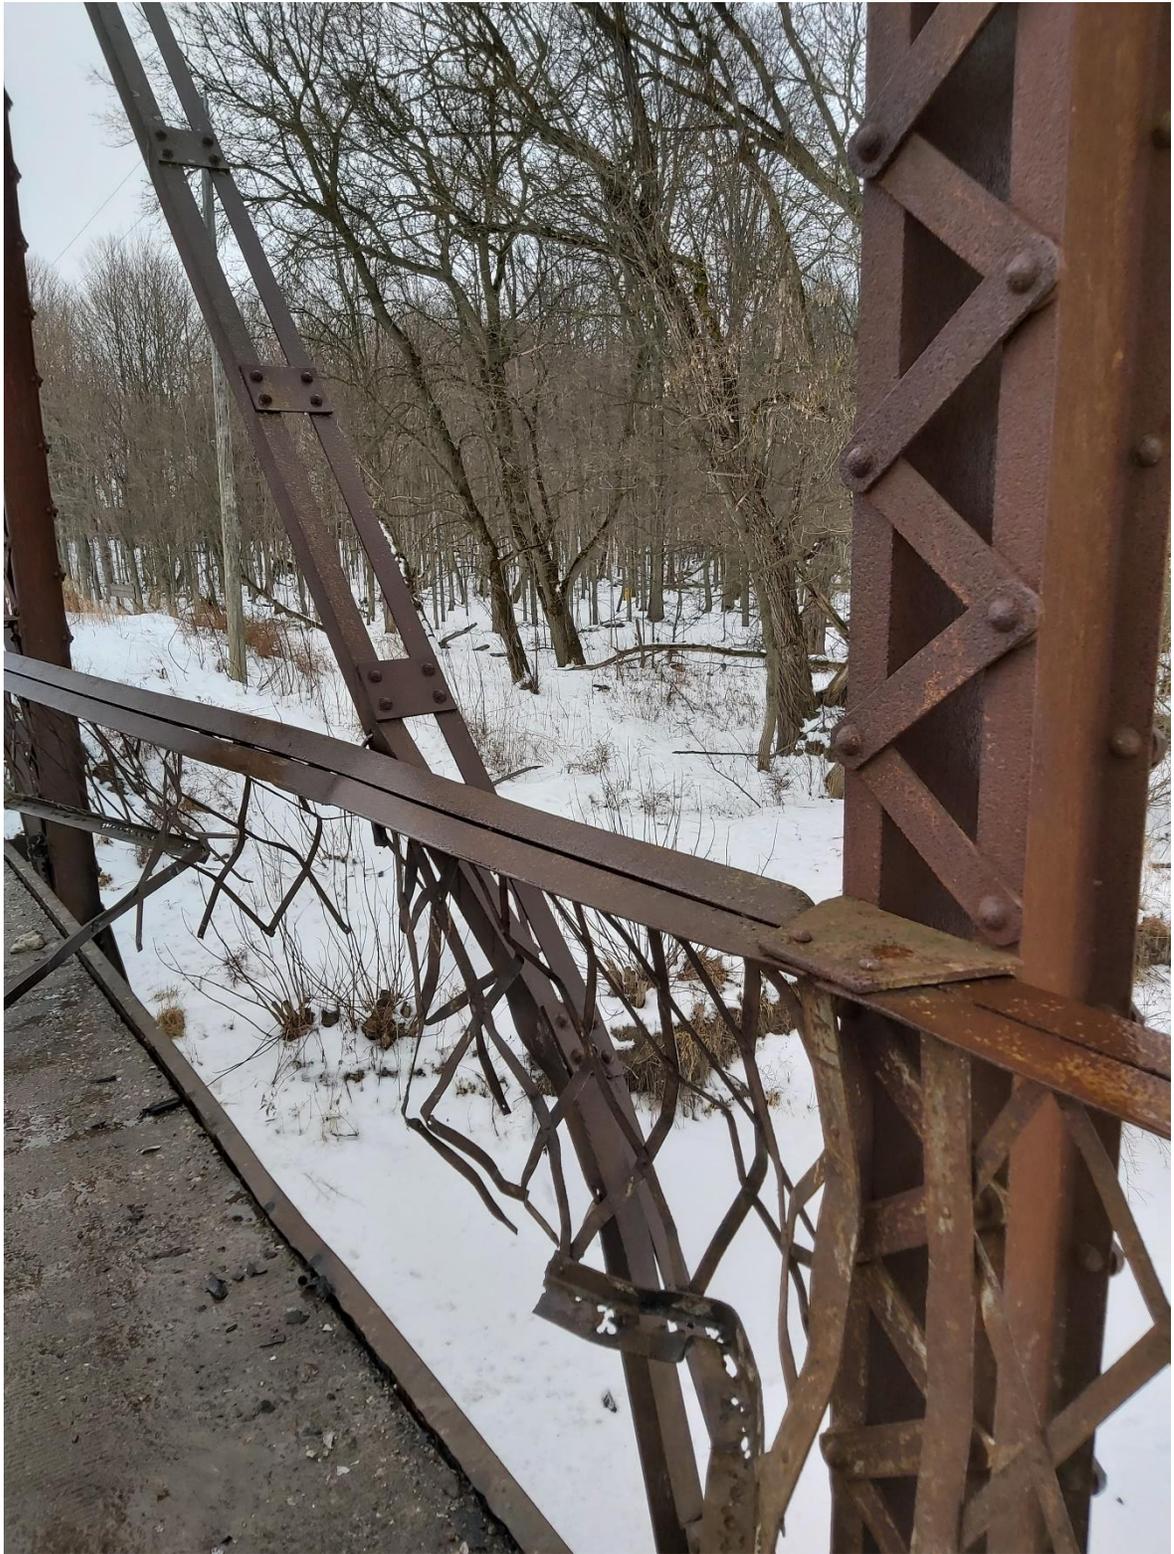
- Second bay from east: some damage to the railing
- Third bay from east: railing is completely destroyed
- Third bay from east: diagonal structural members are severely twisted and deformed. The inner diagonal structural member is broken near the bottom connection
- Seventh bay from east: has heavy damage to the railing

In closing, the vehicle impact caused major damage to a main load carrying member of this bridge as well as to the barrier / railing system at several locations. The damage inflicted to the diagonal members at the third bay from the east on the south side severely reduces the structural capacity of the structure. The areas of severe railing damage make the bridge unsafe for public use. The concrete deck does not appear to have suffered damage, however it was covered with fuel absorbent so the inspection was very limited. Any possible damage to structural members from exposure to direct heat from the fire cannot be assessed through a visual inspection alone.

South Side, third bay from east end - Severe damage at railing panel and diagonal structural member.

Minimum repairs required for a re-opening of this crossing would involve placing new steel railings at two areas of the most severe damage and the replacement of the diagonal structural members at the third bay from the east on the south side. Reinforcing the vertical member on the north side should also be considered. We propose that the new railing need not match the lattice work steel for this temporary repair. The estimated construction cost for these repairs would be approximately \$35,000 to \$50,000. The estimated engineering fees for design, preparation of drawings and specifications for tender, and review of repairs is estimated at \$10,000 to \$15,000. (The ranges are due to the very preliminary nature of the scope of work required at this time)

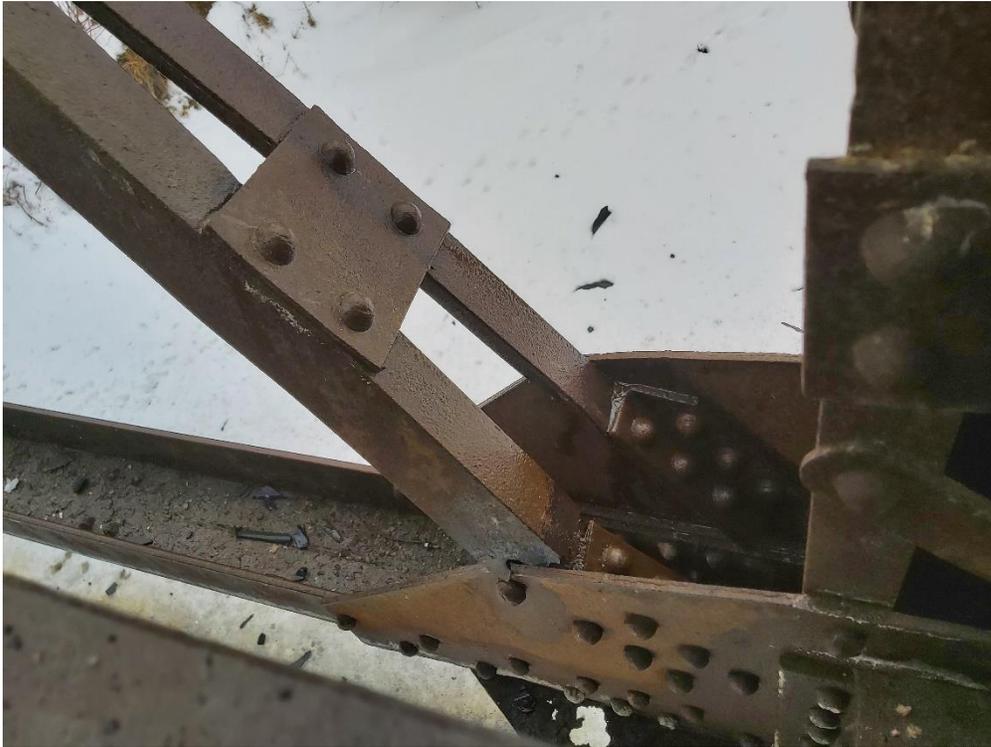
South side, third bay from east end – damage at diagonal structural member. Interior angle is completely broken above connection plate location.

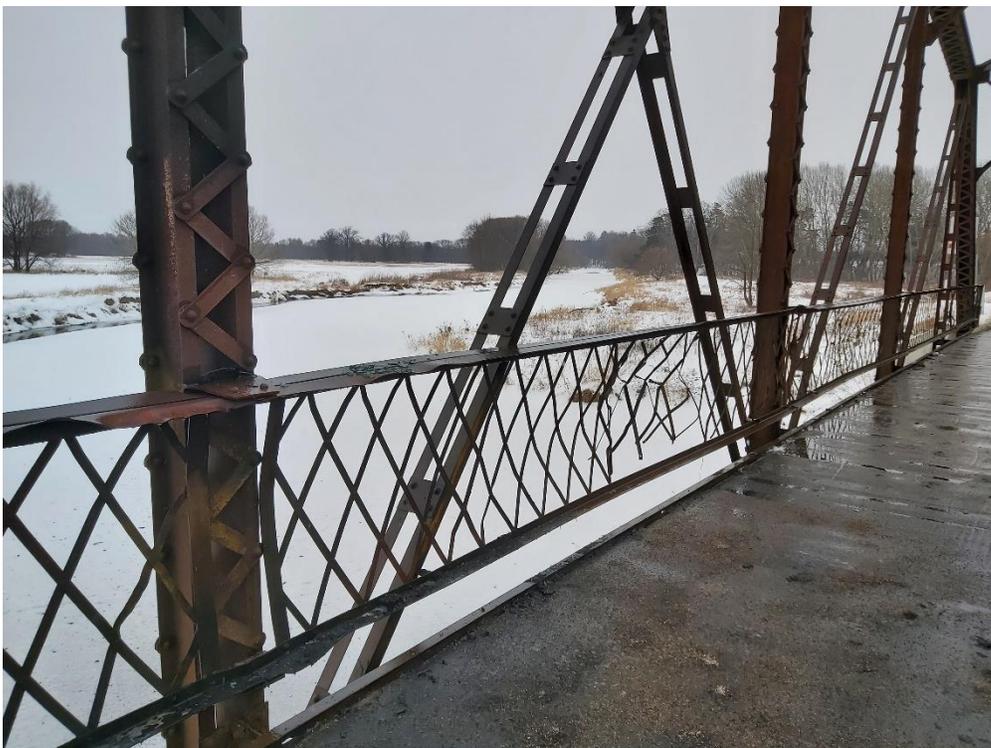
- Third bay from east: the railing panel is bent outwards
- Fourth bay from east: heavy damage to railing with broken pieces
- Fourth bay from east: structural members blackened by fire
- Fifth bay from east: minor damage to railing panel
- Fifth bay from east: minor damage to vertical structural member

North Side, fourth bay from east end – heavy damage to railing panels. Also note blackened area at deck and structural members.

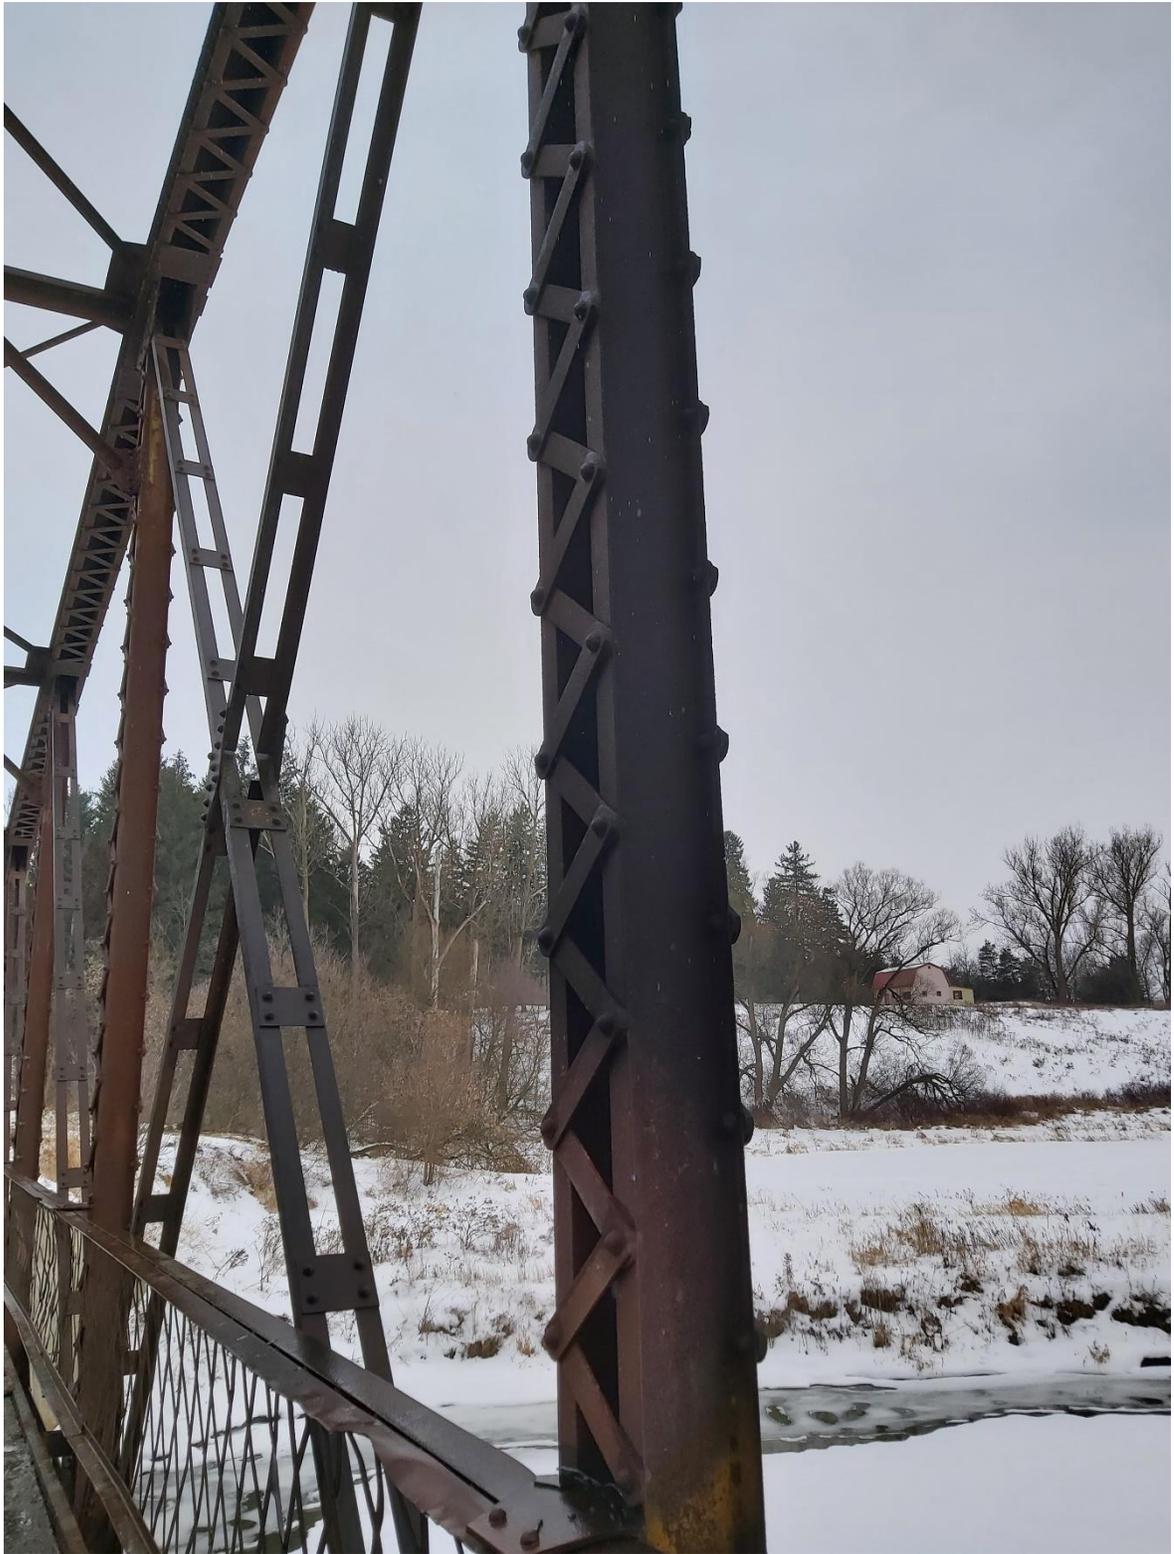
North side, fourth vertical from east end – note blackened areas from vehicle fire

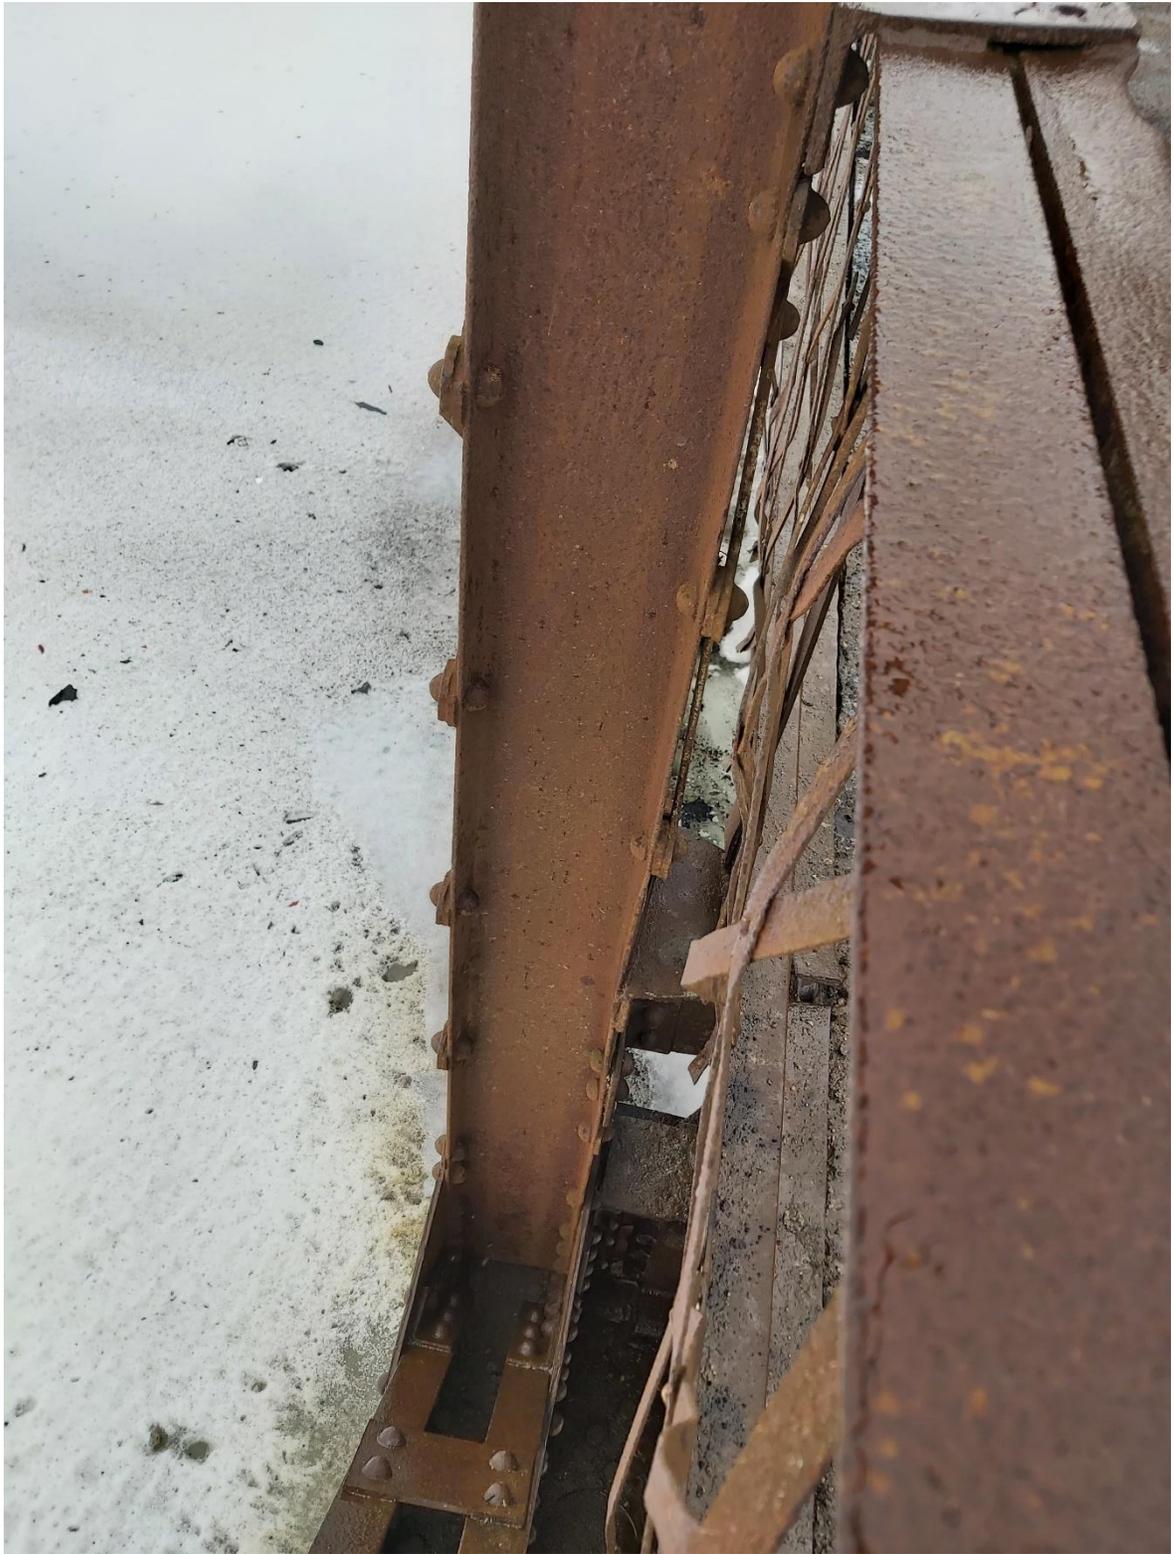
North side, fifth vertical from east end – minor deformation of vertical member from impact
